SPECIAL PUBLICATION 116

THE NORTHRIDGE, CALIFORNIA, EARTHQUAKE OF 17 JANUARY 1994

DIVISION OF
MINES AND GEOLOGY

**The Northridge, California, Earthquake
of 17 January 1994**

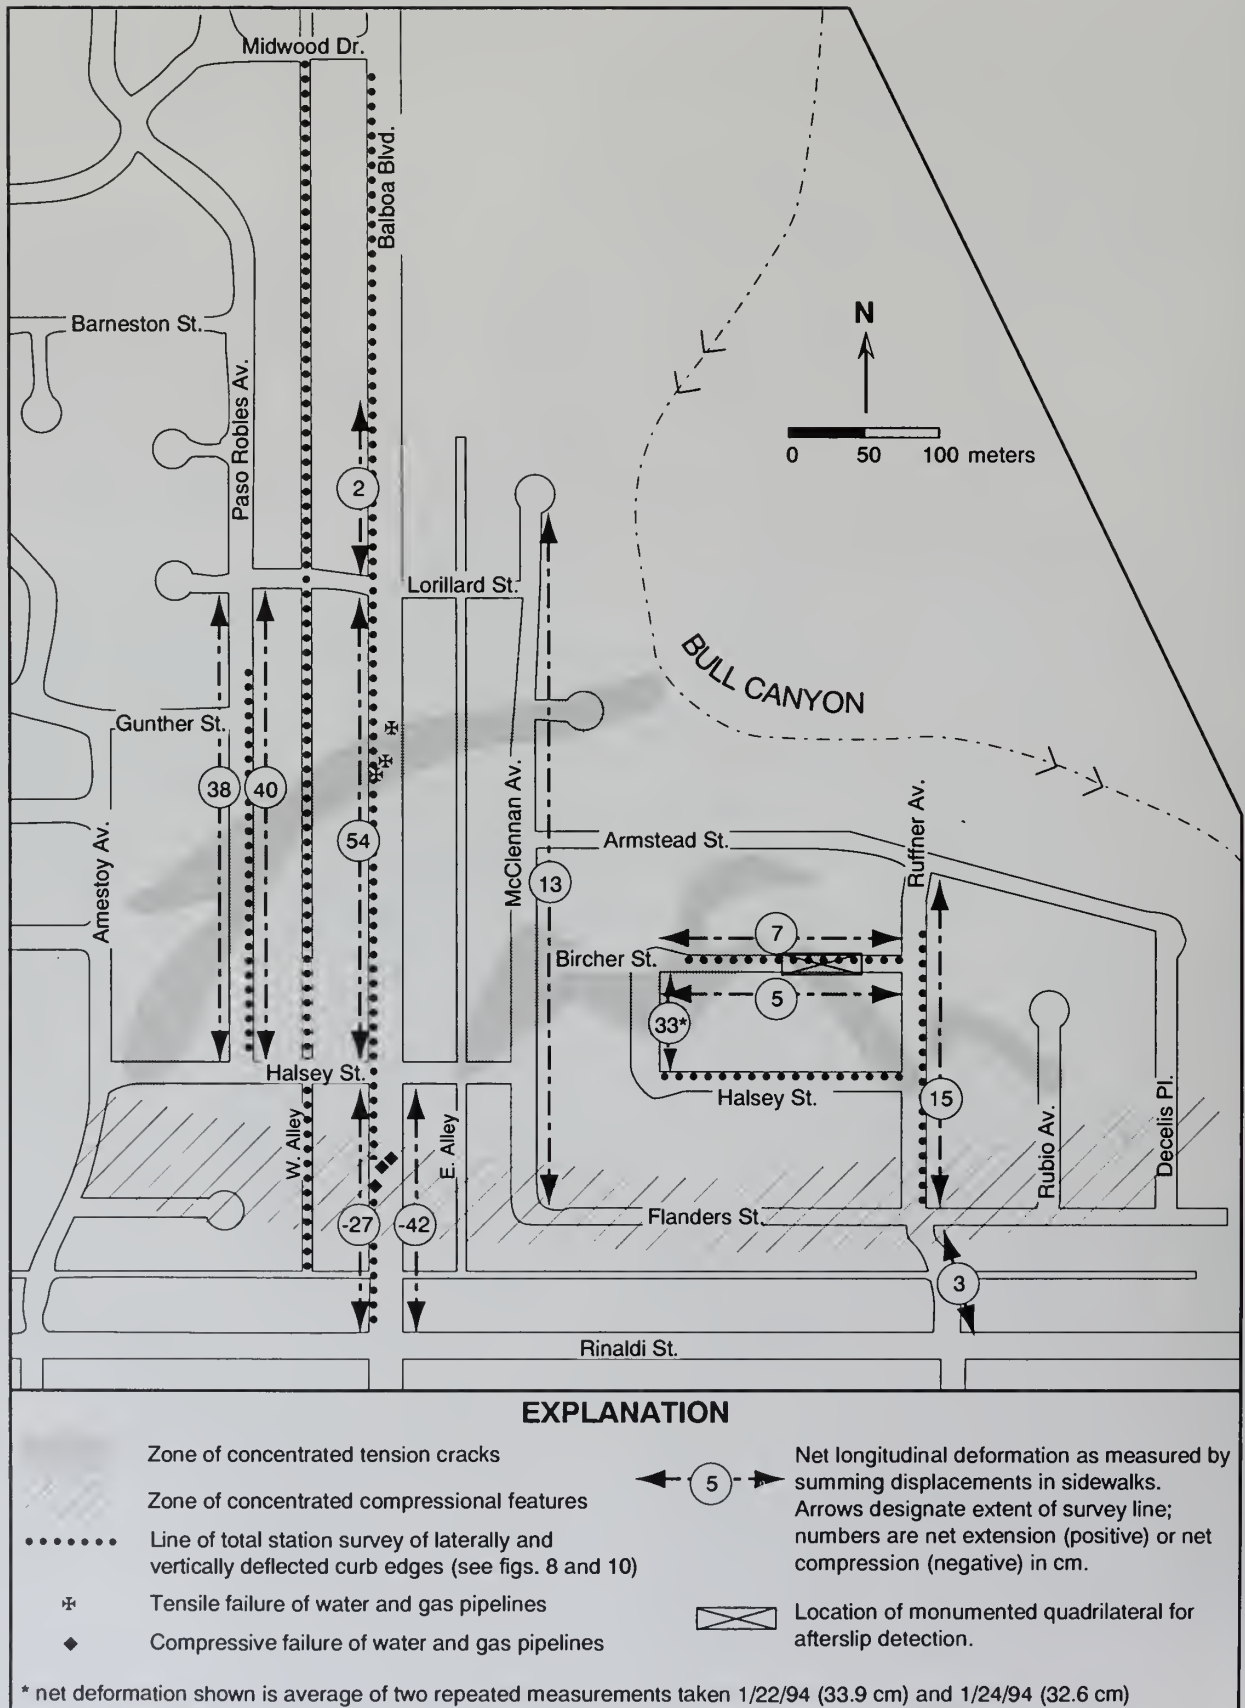
Figure 4. Generalized map of the Granada Hills deformation zone west of Bull Canyon, showing locations of survey lines and amounts of longitudinal (street parallel) deformation.

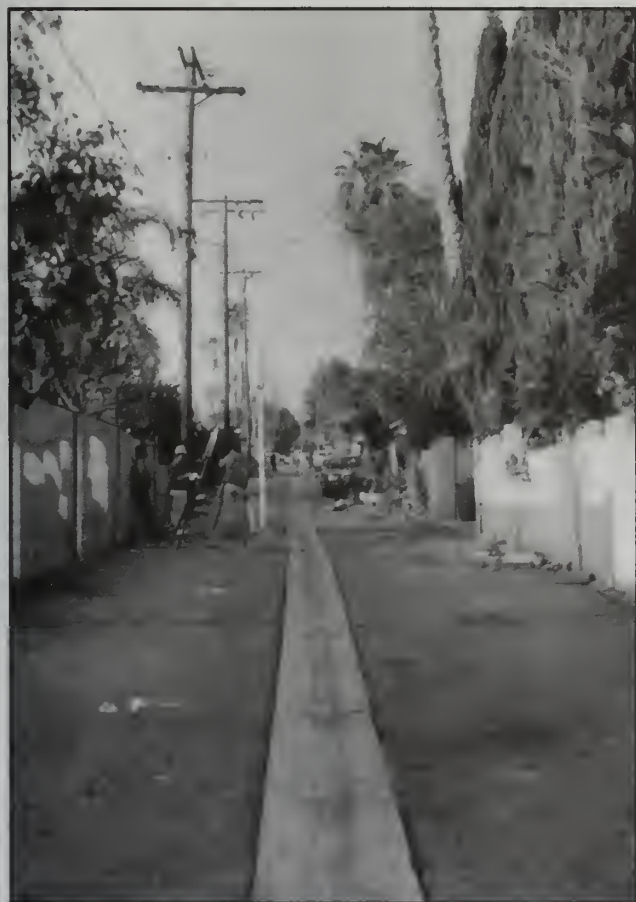
Photo 4. View to the north across principal zone of tension cracks in the alley between Paso Robles Ave. and Balboa Blvd.. Eastward movement of the alley is clearly demonstrated by the apparent left-lateral deformation of the concrete drainage gutter where it crosses the crack zone. Photo by D.J. Ponti.

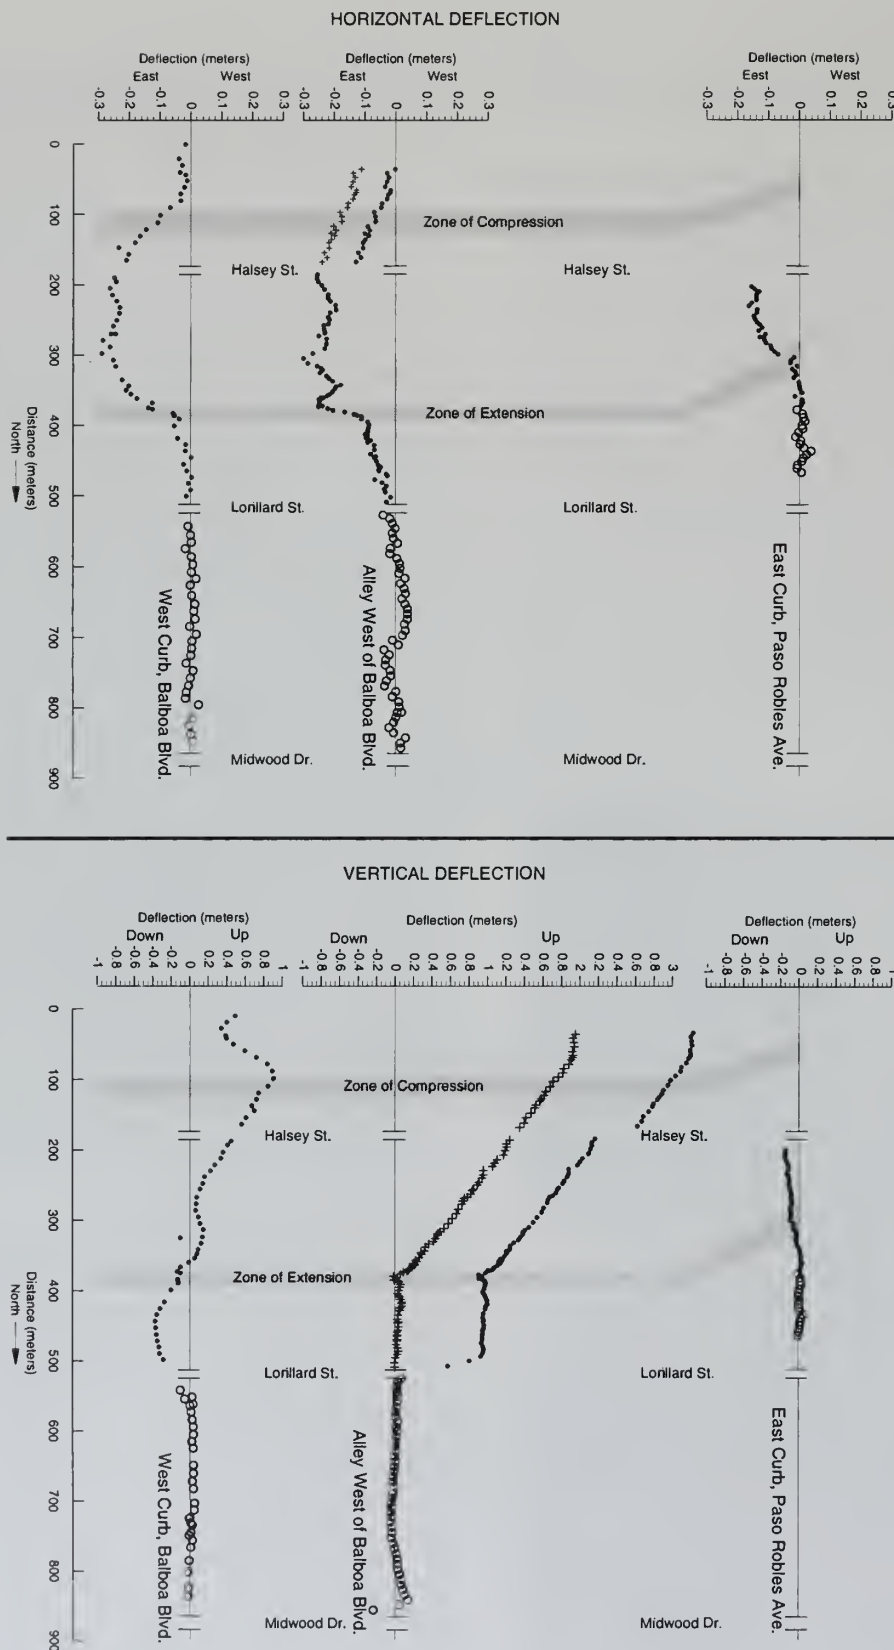
Three N-S profiles located between Balboa Blvd. and Paso Robles Ave. show that curbs and drainage gutters are deflected eastward across the principal subzone of tension cracks (Figure 5). This deflection, which reaches a maximum of ~ 30 cm, appears as left-lateral deformation across the subzone (Photo 4) and is consistent with observed southeast-directed extension. A nearly equal amount of westward (or right lateral) deflection is observed on the profiles (of Balboa Blvd. and the alley west of it) where they cross the subzone of concentrated compressional deformation (Figure 5). This sense of lateral deformation is consistent with compression directed toward the southeast, which is the direction of ground movement observed in the extensional subzone to the north. Plots of vertical deflection along the Balboa Blvd. and west alley profiles (Figure 5) reveal that the ground-surface slope abruptly decreases $\sim 0.3^\circ$ across the subzone of tension cracks and steepens slightly

Figure 5. Plots of lateral and vertical deformation of concrete curbs and drainage gutters along N-S profiles between Balboa Blvd. and Paso Robles Ave. Locations of lines shown on Figure 4. Open circles designate stations outside of the deformation zone used to define straight line references; solid circles are stations presumed to be within the zone of deformation. Plus symbols are station locations corrected for man-made offsets across street intersections. Surveys show an abrupt eastward deflection of the profiles across the zone of extension and a nearly equal, although not nearly as abrupt, westward deflection with the zone of compression. Slopes also appear to decrease abruptly across the zone of extension.

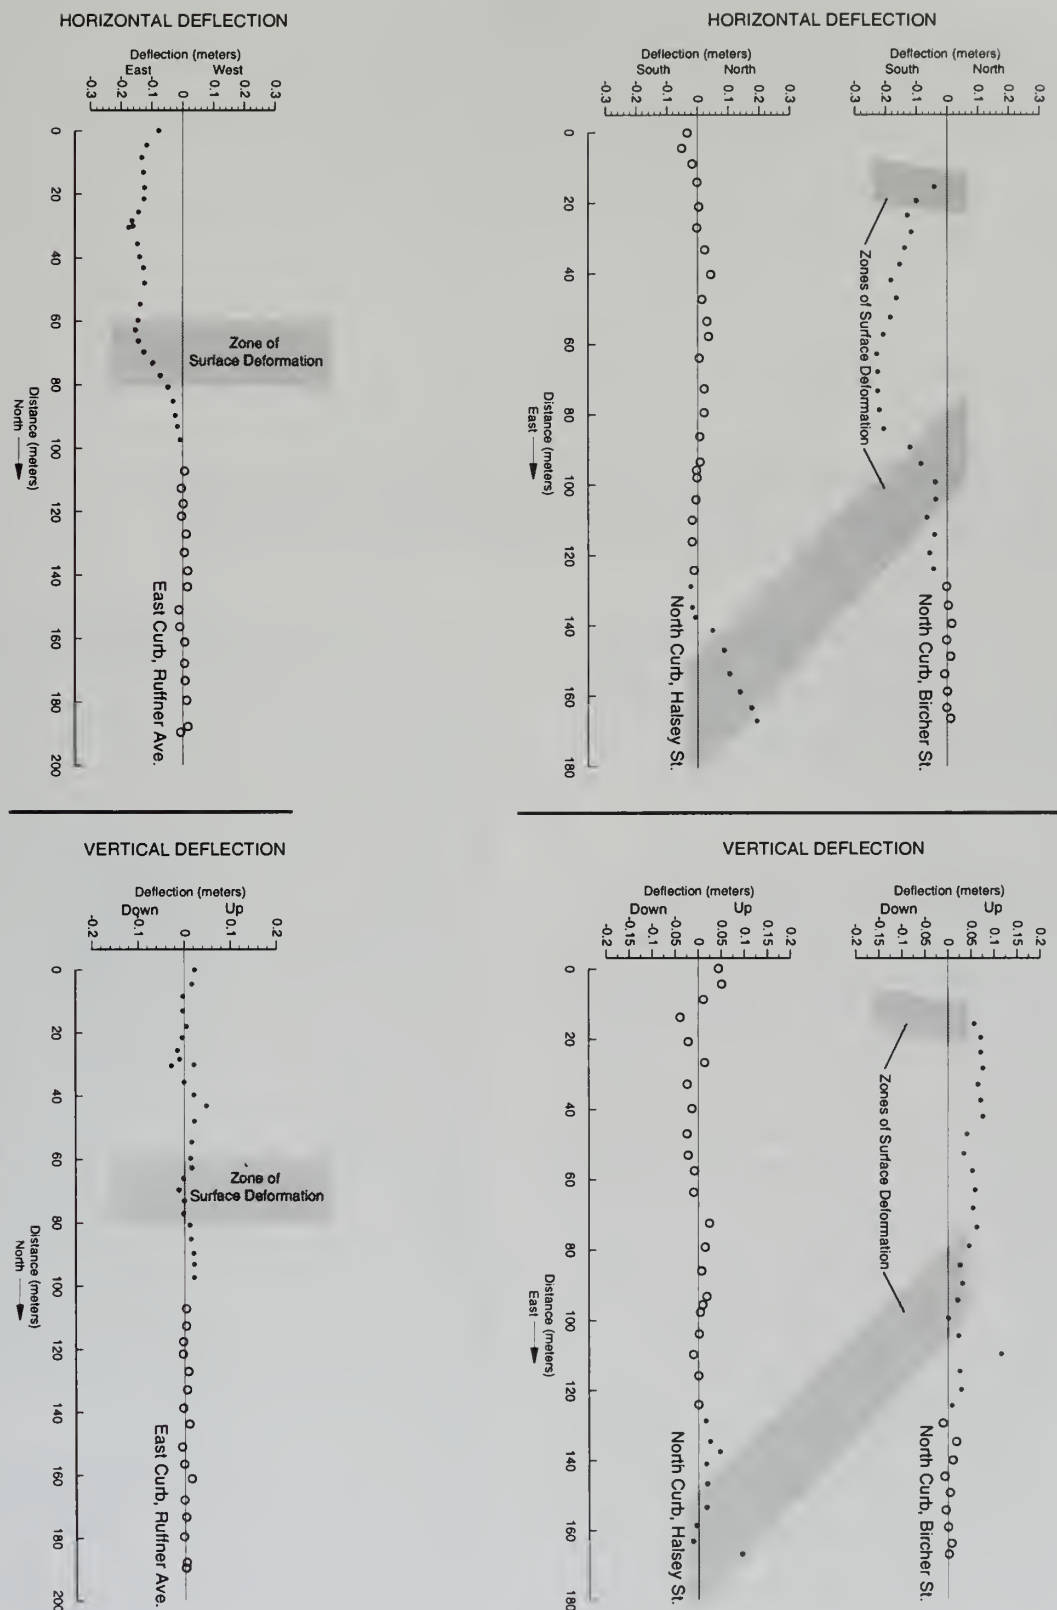
Measured profiles east of Balboa Blvd. (Figure 6) are consistent with field observations that suggest southeast-directed extension. Approximately 16 cm of eastward (left-lateral) deflection of Ruffner Ave. appears to be due to left-shear and extension on a southeast-trending subzone of cracks (Figure 4). East-trending Bircher St. is deflected sharply southward (left-laterally) where it crosses the same southeast-trending, left-extensional subzone that deforms Ruffner Ave., but appears to be deflected in the opposite sense (right-laterally) at its western end where it intersects an east-to-northeast-trending subzone of southeast-directed extension. Halsey St., one block to the south of Bircher St., shows similar left-lateral deformation within the southeast-trending subzone of cracks (near the intersection with Ruffner Ave.). Figure 7 illustrates how the sense of lateral deformation (either right or left) of roads in the area varies with respect to the trends of both roads and crack zones. Unlike the profiles west of Balboa Blvd., the elevation data for this area does not show any clear trends.

Figure 6. Plots of lateral and vertical deformation of concrete curbs along E-W and N-S profiles east of Balboa Blvd. Locations of lines shown on Figure 4. Open circles designate stations outside of the deformation zone used to define straight line references; solid circles are stations presumed to be within the zone of deformation. See text for discussion.

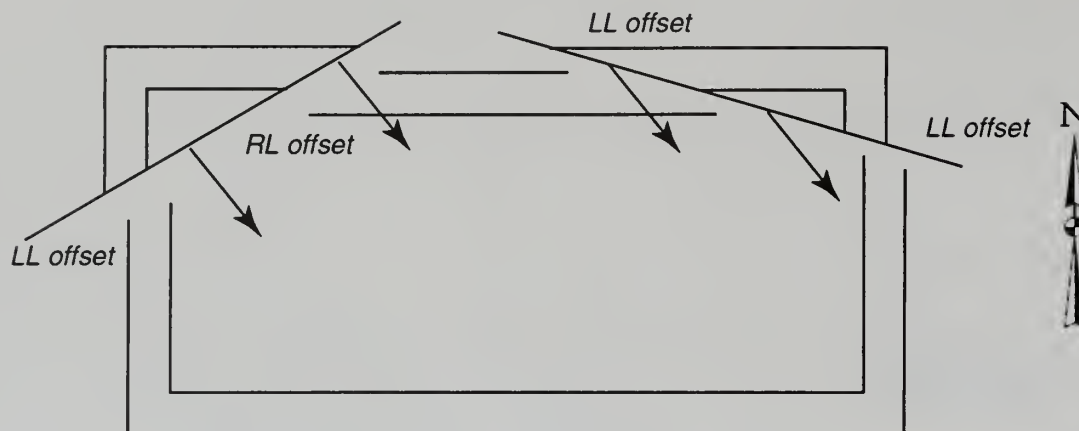
Figure 7. Diagram illustrating sense of lateral deflection of N-S and E-W roads across a region of SE extension, as is observed for the area west of Bull Canyon. Crack zones oriented NE-SW deflect N-S roads left-laterally (i.e., Balboa Blvd.) and E-W streets right-laterally (i.e., west end of Bircher St. near McClennan Ave.). Crack zones oriented NW-SE deflect N-S streets left-laterally (i.e., Ruffner Ave. near Halsey St.) and E-W streets left-laterally (i.e., Bircher St. near Ruffner Ave.).

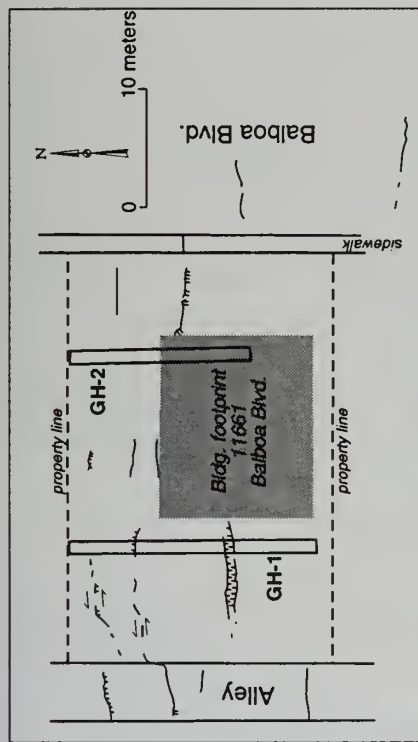
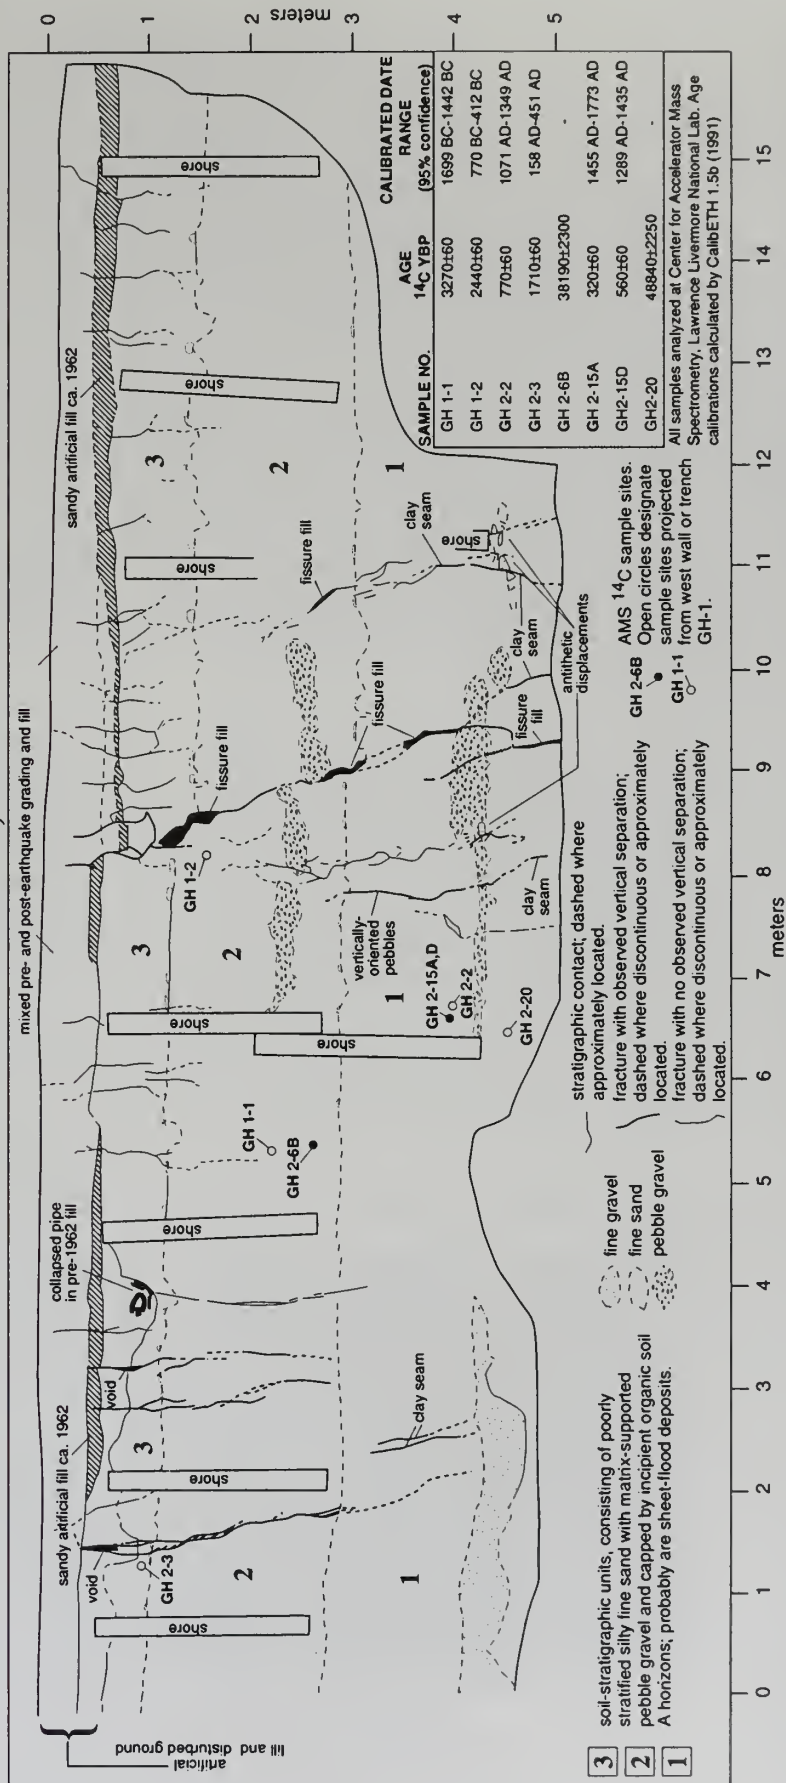
LOG OF TRENCH GH-2, EAST WALL

Figure 8. (a) Map showing location of ground cracks at 11661 Balboa Blvd. and location of trenches GH-1 and GH-2. (b) Simplified log of east wall of trench GH-2. Movement on the principal crack in 1994 (located between meters 8 and 10) displaced base of the artificial fill 22 cm vertically, but displaced top of unit 1 only 12 cm.

The ground fractures extend across a zone more than 12 m wide in trench GH-2 (Figure 8b). They are expressed as combinations of open and closed cracks, narrow shear zones, clay seams, and water-laid (from pipe-burst flooding) fissure fills. Fractures are easiest to see in the artificial fill and in unit 3, where desiccation of clay-rich material causes cracks to open further. Fractures that appear to die out downward in unit 3 (Figure 8b) may be due to desiccation only and have no relation to ground failure. Fractures are generally more difficult to discern in unit 2 and in the upper part of unit 1, except where marked by pipe-and-fill sequences. Several fractures are well expressed as brown, clay-rich seams within the lowermost meter of unit 1. All of the fractures in the trench have steep dips, ranging from nearly vertical to $\sim 70^\circ$ S, although some dip steeply to the north over short intervals.

Although several fractures can be traced to the bottom of GH-2, only one (the large, front-yard fracture discussed above) has substantial vertical displacement. All of the displacement on this main fracture occurred in 1994, and the amount appears to decrease with depth in the trench. The base of the artificial fill steps down to the south 22 cm across the fracture, whereas the top of unit 1 has a vertical separation of only ~ 12 cm (Figure 8b). Because these stratigraphic boundaries are fairly planar and nearly horizontal, the difference in amount of separation across the fracture probably represents a true difference in vertical displacement. Two fractures in trench GH-2 have small, north-side-down displacements totaling ~ 4 -7 cm. These displacements are present low in the section only, within but not at

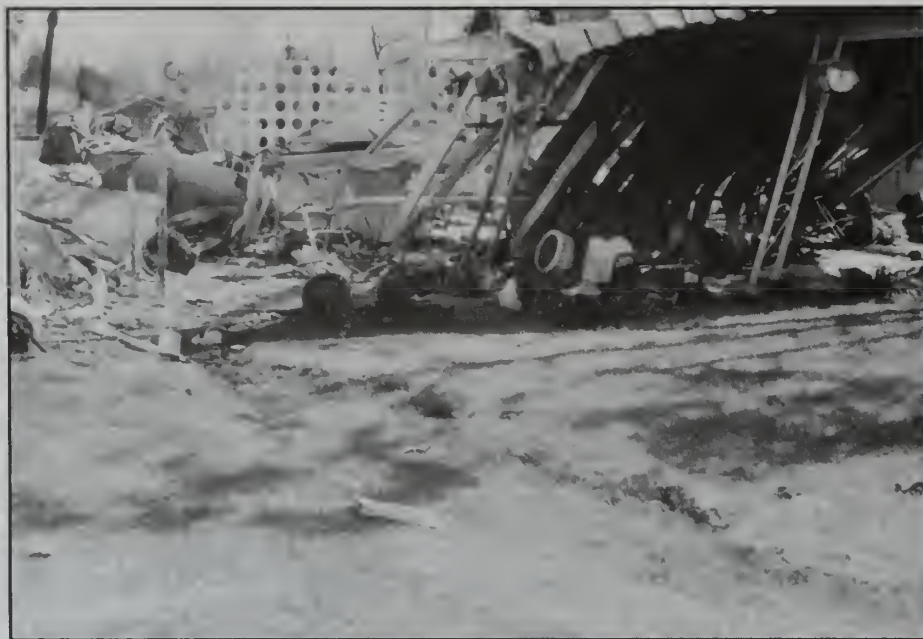
Photo 5. View to the southeast of small graben on the west side of the lot at 11661 Balboa Blvd. (see Figure 8a). Photo by S. Hecker.

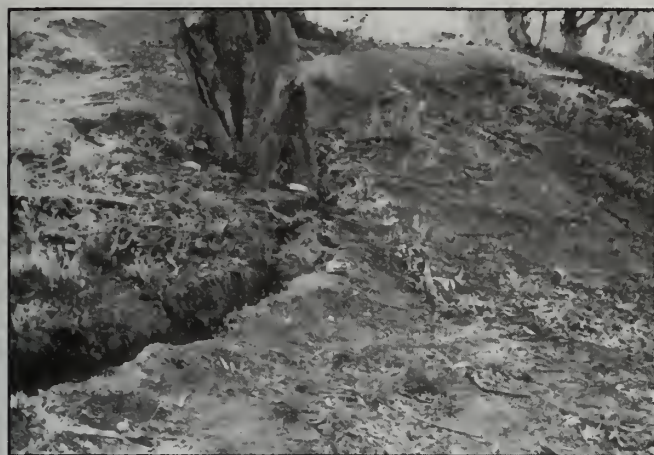
A 150-meter-long zone of cracks developed along the storm-drain alignment, on and at the base of the southwest wall of the present channel cut (Figure 3, locality 3). Individual cracks are as long as 50 m, have a decimeter or more of opening, and form vertical scarps that face toward the channel (Photo 6). Liquefaction may have contributed to ground failure here, as indicated by a small area of vented sand on the channel floor near the downstream end of the zone.

Photo 6. Tension crack on the southwest wall of the Bull Creek channel (view to the west; near locality 3, Figure 3). Photo by T. E. Fumal.

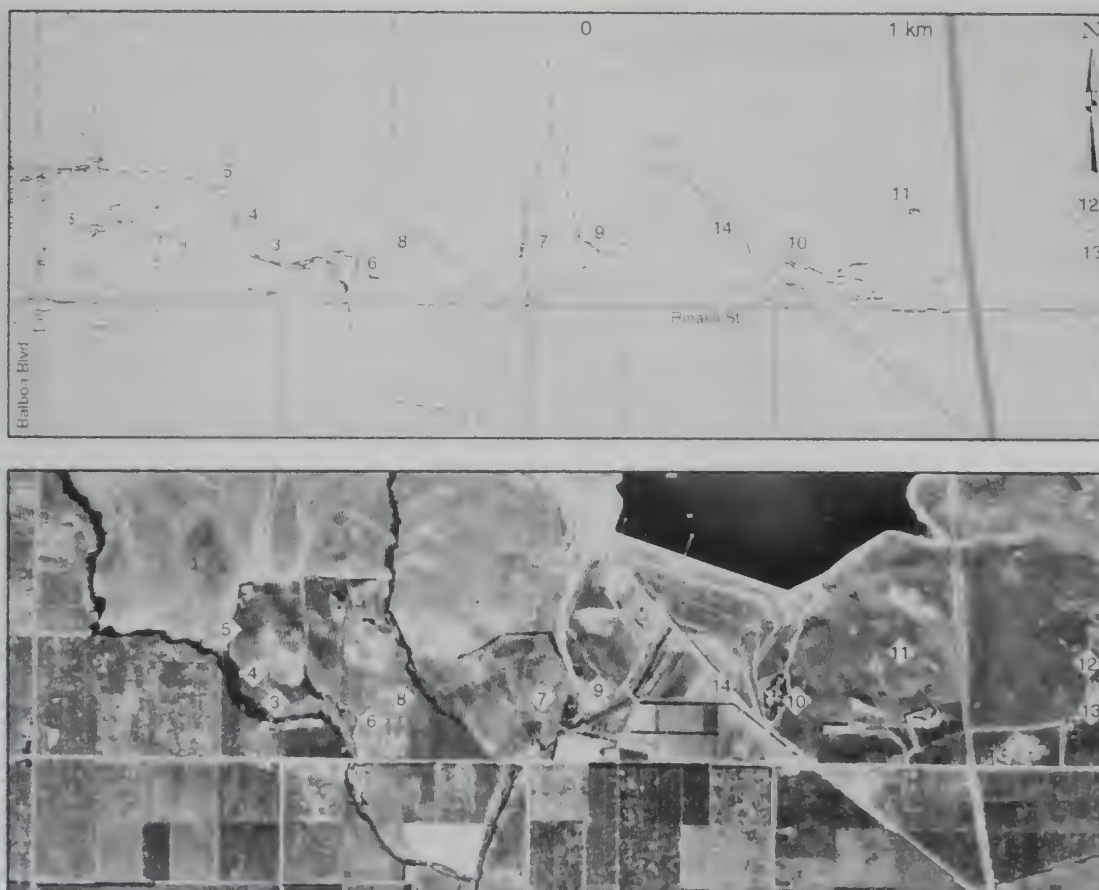
The 150-meter-long crack zone at locality 3 that follows the southwest wall of lower Bull Canyon is part of a longer zone of deformation that continues eastward onto Halsey St. and then southward onto Odessa Ave. (Figure 3). These streets follow the course of the old stream bed and are constructed on artificial fill placed in the channel (Figure 9). Top soil mounded against the sidewalk on the south and west sides, respectively, of Halsey St. and Odessa St. (Photo 7) and pavement compressed against concrete curbs on the other sides of these roads are evidence for compression orthogonal to both Halsey and Odessa. Tension cracks formed parallel to the compressional features, but are less extensive and record less movement (typically ~1-2 cm opening versus ~5 cm shortening). A series of closely spaced tension cracks also developed transverse to Odessa Ave. (Figure 3). Another zone of tension cracks takes a path through several houses and lots east of Odessa Ave. (Figure 3, locality 6). As shown in Figure 9, these cracks follow an abandoned meander bend along the old incised channel of Bull Creek.

Figure 9. 1947 aerial photograph of the Granada Hills–Mission Hills area showing location of drainage channels prior to urbanization. Many of the ground cracks that formed in 1994 (shown in line drawing) are adjacent to or overlie these old channels (localities 3-9). Note particularly the geometry of the ground cracks at locality 6 and the existence of an abandoned meander bend at the same location.

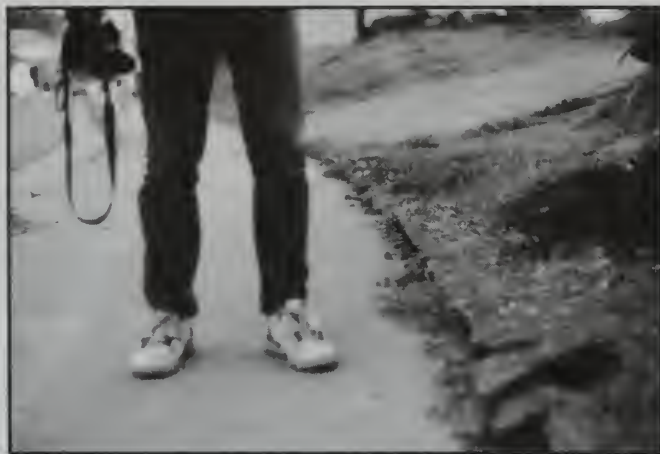
Photo 7. Top soil thrust over sidewalk along the west side of Odessa Ave. View to the south. Photo by D.P. Schwartz.

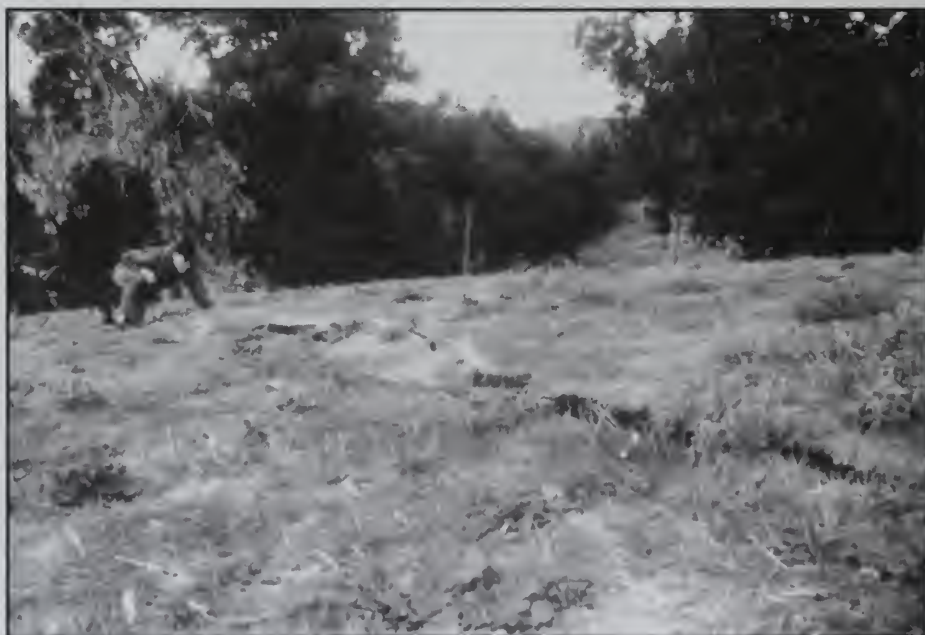
Two subzones dominated by tension cracks and small normal-fault scarps developed low on the south flank of the Mission Hills anticline west of Interstate 405 (Photo 8). The subzones are each about 350 m long, approximately parallel, and cross from open ground into a densely developed housing complex (Figure

Photo 8. Example of tension crack and small scarp on south flank of the Mission Hills anticline (near locality 10, Figure 1). View to the northwest. Photo by C.D. Garvin.

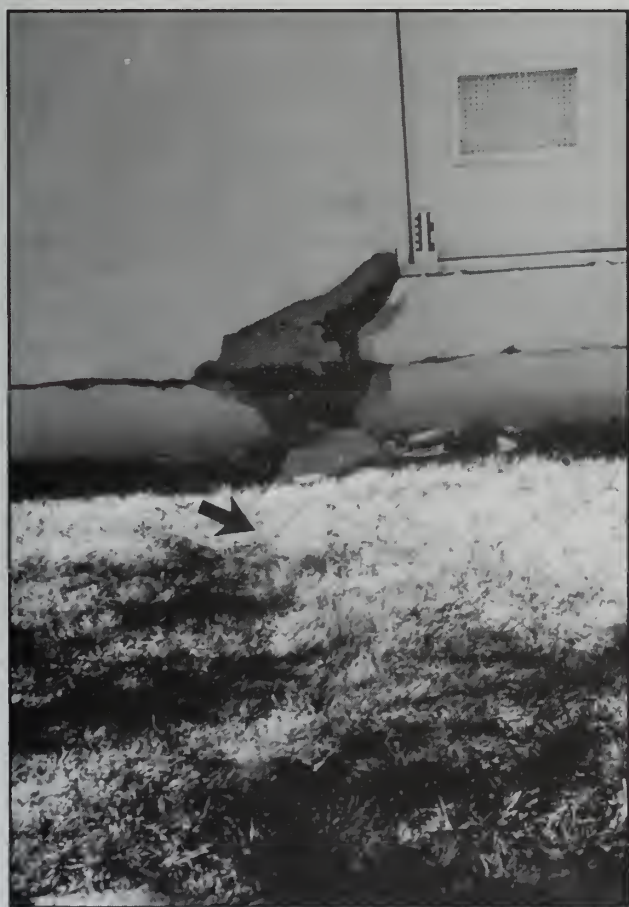
Photo 9. Foundation slab of a house broken by a ground crack (arrow), south side of Armstead St. The house was one of two on the street that were substantially damaged and assigned "red" inspection tags (Figure 3). Photo by M.J. Rymer.

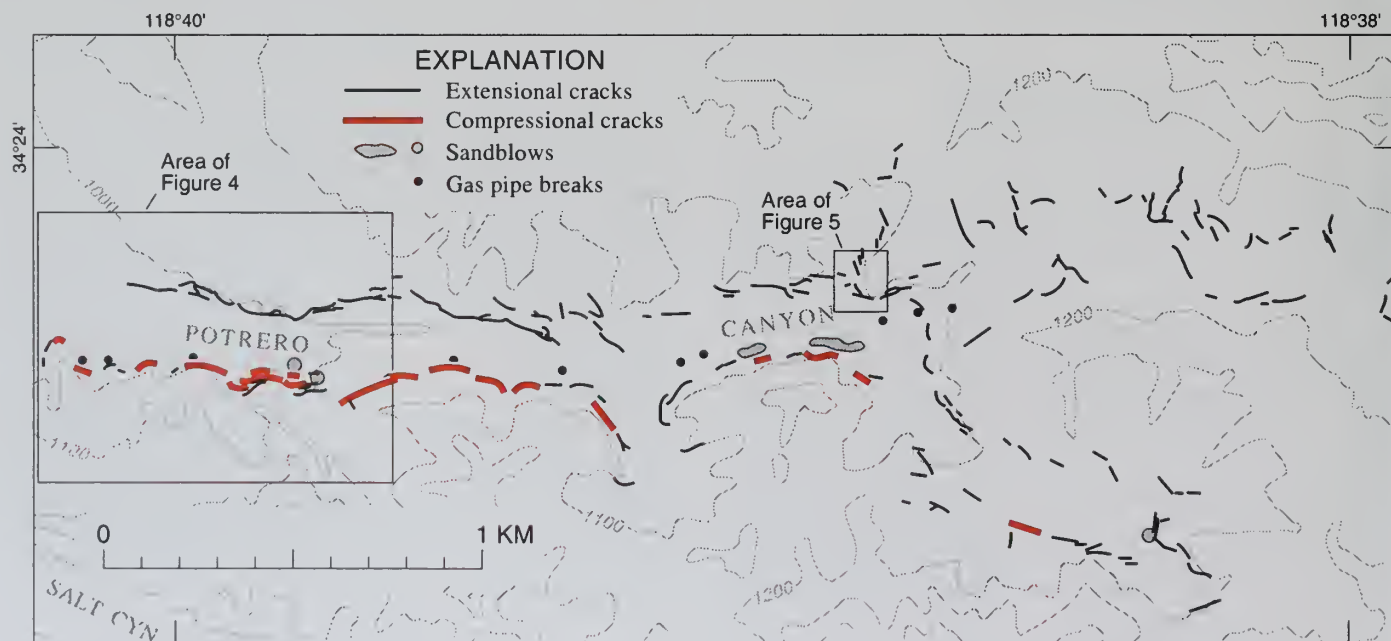
Extensive sets of surface fractures, with east-west and north-south limits of about 3.6 km and 1.3 km, respectively, formed in alluvium around the margins of Potrero Canyon (Figure 2; see also Rymer and others, in press, for larger-scale and more detailed plots of fractures). Most fractures occur along the contact between bedrock and alluvium, commonly near the base of hillslopes.

Figure 2. Surface fractures and other earthquake-induced features formed in Potrero Canyon in association with the 1994 Northridge earthquake.

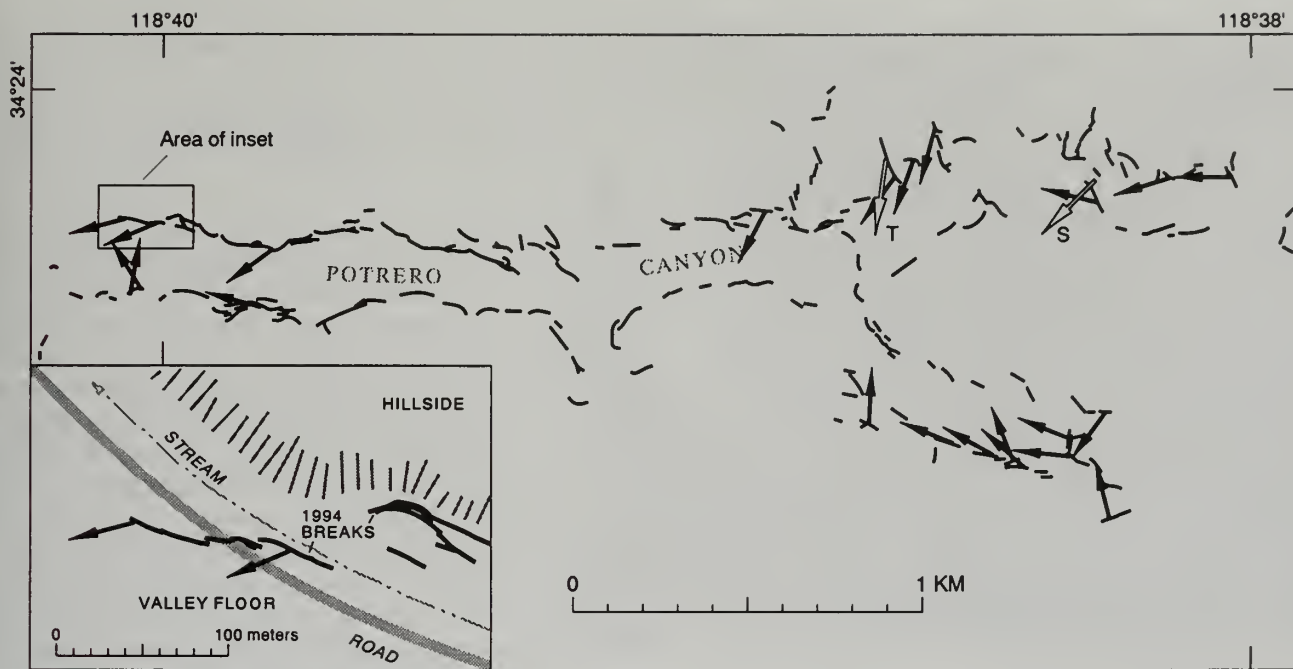
Figure 3. Map of horizontal slip directions across matching soil-block irregularities plotted relative to surface fractures in Potrero Canyon. Two hollow arrows in the northeast indicate horizontal slip directions of man-made features on the ground surface; these are marked with S = tank of soda ash and T = transformer. Inset map shows northwestern end of Potrero Canyon and 1994 surface fractures (heavy lines); horizontal slip directions show motion down canyon and not necessarily toward topographic free-face of the stream channel.

Several lines of evidence from both sides of the canyon indicate that alluvium moved toward the center and the down-stream end of the canyon. This is indicated in Figure 3, which shows horizontal slip direction measured across individual cracks or narrow crack sets. Also, extensional fractures on both sides of Potrero Canyon and in the side canyon most commonly occur or are more pronounced on the west sides of spurs or ridges that protrude into the canyons (Figures 2, 3, 4, and 5). An example of this phenomenon is found at the western end of fractures on the north side of the canyon. Here, cracks extend across a creek, and show horizontal slip directions toward the canyon center (Figure 3, inset). The cracks developed along the alluvium-bedrock contact, which is locally crossed by the creek, and slip along the cracks occurred in a general westward, down-canyon direction and toward the center of alluvial fill. Fractures on the south side are typically right-stepping and those on the north side are typically left-stepping, also indicating a net down-canyon (westward) movement of the alluvial fill.

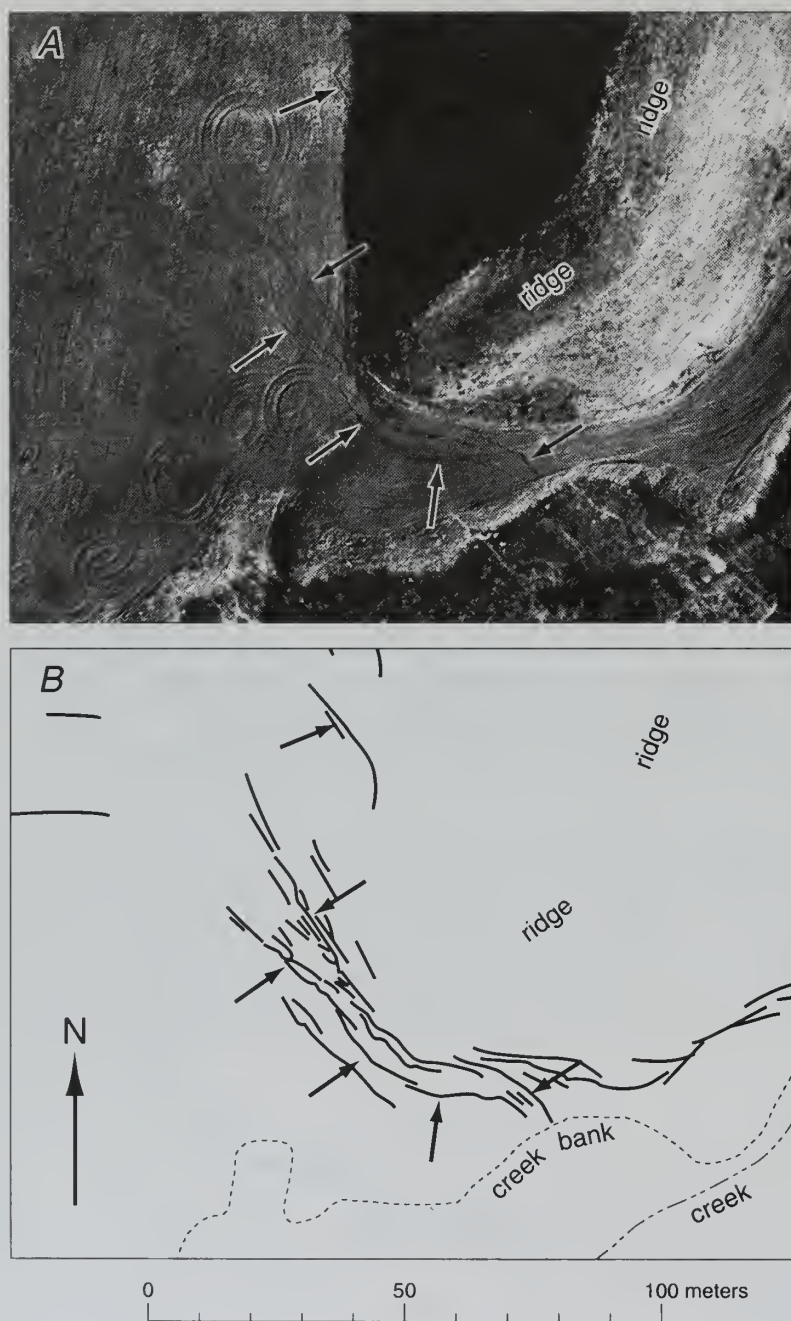
Figure 5. Surface fractures on north side of Potrero Canyon showing better developed cracks on west side of ridge spur that protrudes into canyon. A, aerial photograph of surface fractures, prominent fractures marked by arrow. Features seen on cultivated ground include plow marks, tractor turn marks (not crop circles), and cattle trails. B, Line drawing of same area shown in A. Heavy line, surface fracture.

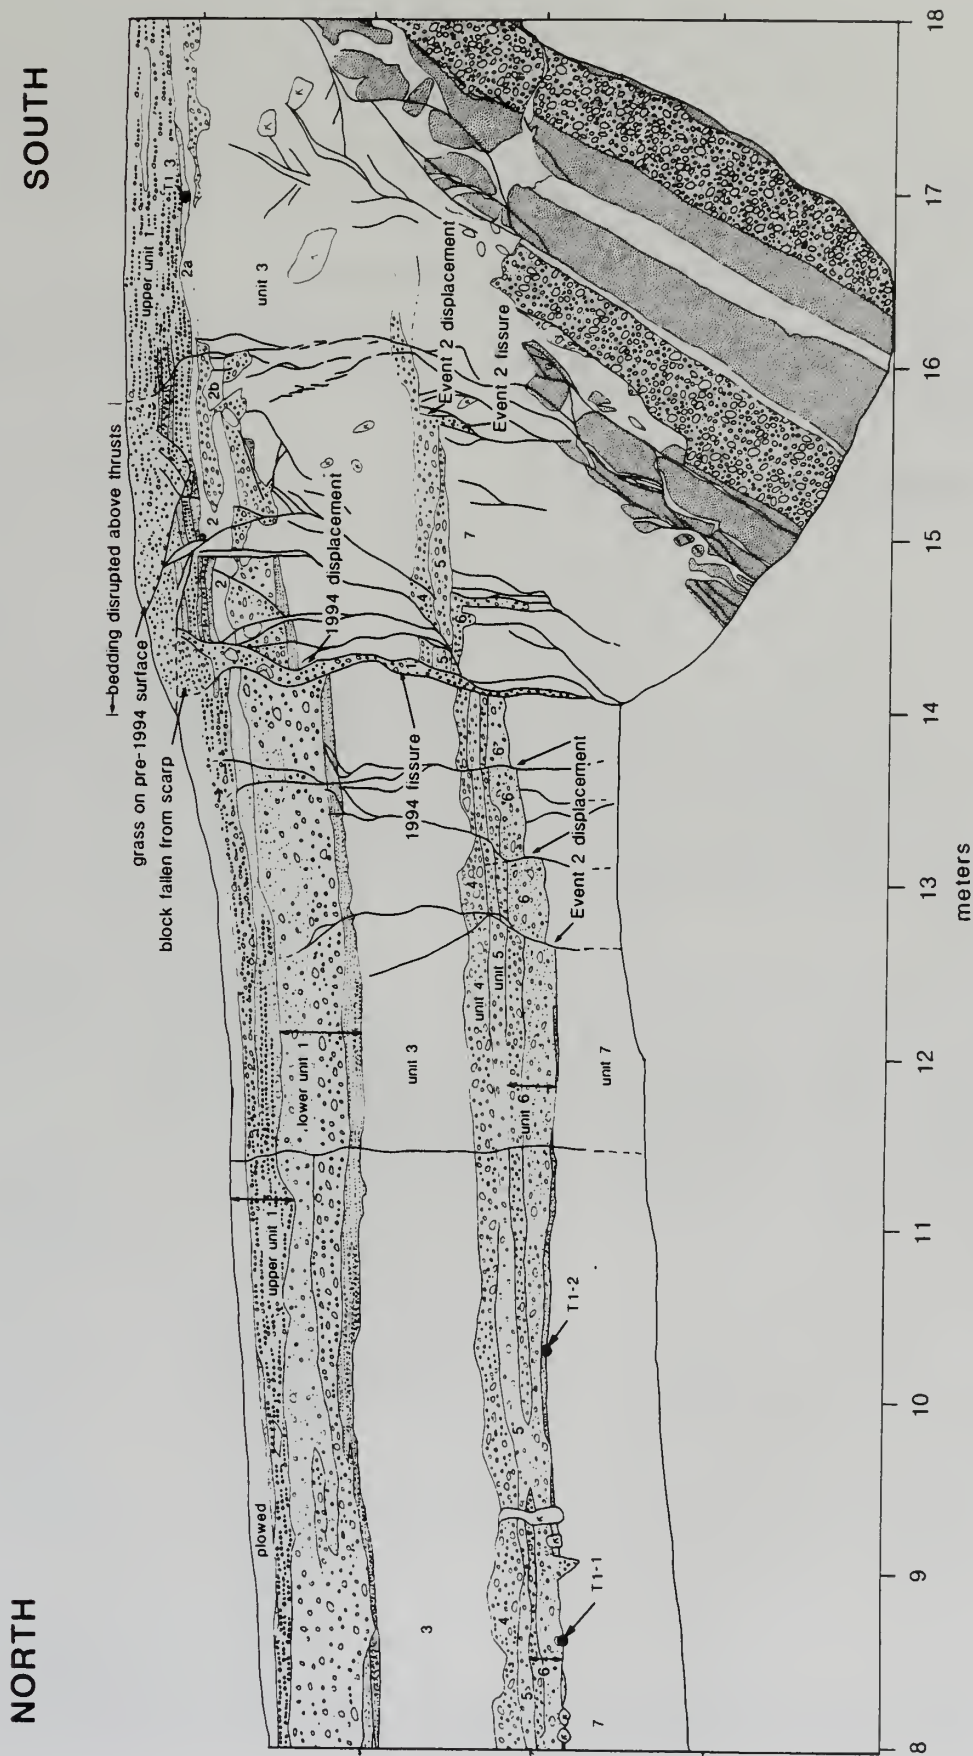
Figure 8. Log of Trench 1, east wall, in Holocene fluvial deposits and steeply dipping Pico Formation on south side of Potrero Canyon (see Figures 4 and 6 for location). See Figure 7 for description of units. Large solid dot, ¹⁴C sample locations (see Table 1); K = krotovina (rodent burrow). See text for description of event horizons and event displacement.

Evidence of the penultimate event (Event 2) is found in each of the trenches although there is some ambiguity as to the exact placement of the event horizon. In Trench 1 (Figure 8) pebbly sand from unit 4 is vertically displaced and fills a small fissure at meter 15.8, but the fracturing does not appear to extend into unit 3. Between meters 13 and 14 three fractures displace deposits as high in the section as the base of unit 3. Two of the fractures displace the contact between units 3 and 4 and the north fracture separates the base of unit 5, but not the unit 4-unit 5 contact. Each of these was reactivated as a fracture without displacement during the 1994 earthquake. In Trench 1A (Figure 9), a fracture at meter 2, which is correlative with the Trench 1 fractures at meters 13–14, displaces units 6 through 4 by approximately 12 cm. In contrast, the 1994 displacement, as expressed in upper and lower unit 1, is 4 cm. The penultimate event is well expressed in Trench 2 (Figure 10). At meter 4 on the east wall (Figure 10A), the contact between units 5 and 7 has a vertical separation of 15 cm. This fracture is discontinuous in unit 3, but the unit 3-unit 1 contact is displaced only 3 cm. On the west wall of the trench (Figure 10B), this same fracture is continuous through the complete section. Here, the contacts between units 5 and 7 and units 3 and 5 are both displaced 12 cm,

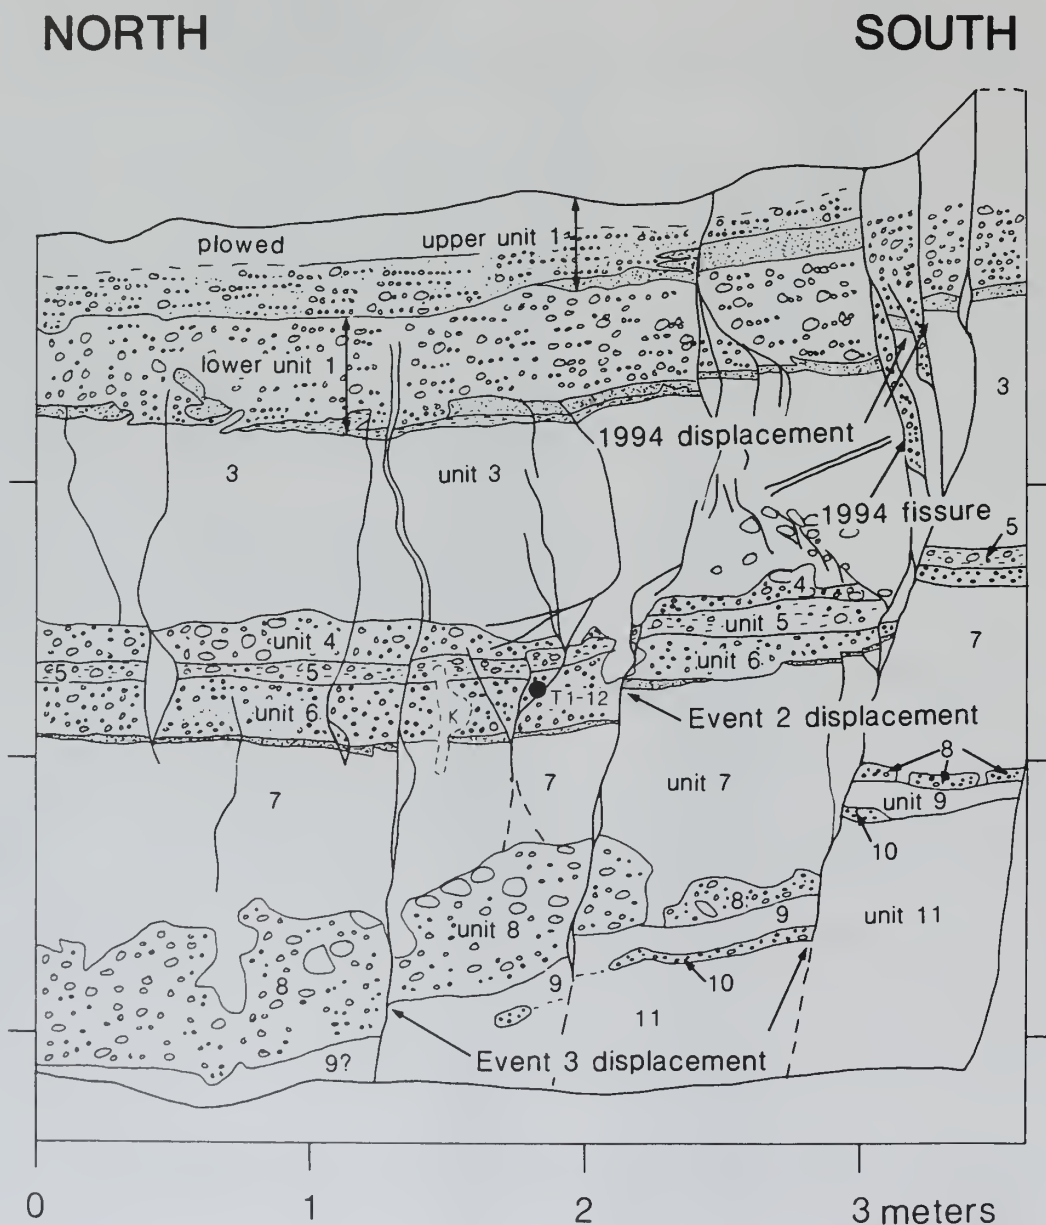
Figure 9. Log of Trench 1A, east wall, in Holocene fluvial deposits on south side of Potrero Canyon (see Figures 4 and 6 for location). See Figure 7 for description of units. Large solid dot, ^{14}C sample locations; K = krotočina. See text for description of event horizons and displacement.

Evidence for the third event back is primarily from Trenches 1A and 2 (Figures 9 and 10). In Trench 1A, displacement across the main fracture, from the surface through the top of unit 7, is consistently about 21 cm (meter 3, Figure 9). All of this occurred in 1994. The net displacement across this zone along the base of unit 7 and in units 8 through 10 is 42–45 cm. This is approximately double the 1994 value and the difference is an expression of Event 3. At meter 1.3, the base of unit 8 is displaced 10 cm, but higher units do not appear to be affected. In Trench 2 (Figure 10), unit 8 is truncated by a fracture at
